# *Post-Earthquake Repair and Strengthening of Historical Palace in Nepal*

Dr. Kit Miyamoto, SE  
Achyut Khanal, PE

### Restoration of the early 20th-century Gaddi Baithak

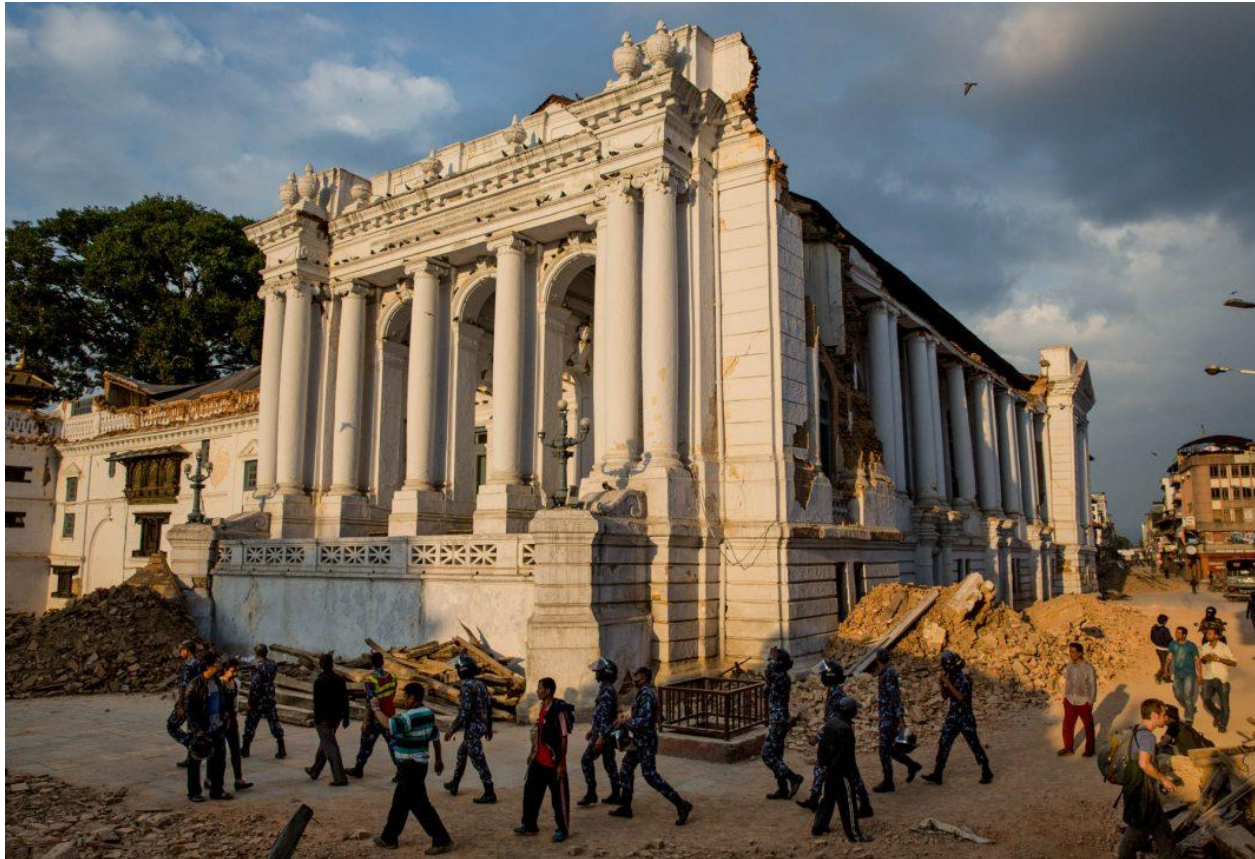
- Destroyed by 2015 earthquake
- Abandoned for 2 years

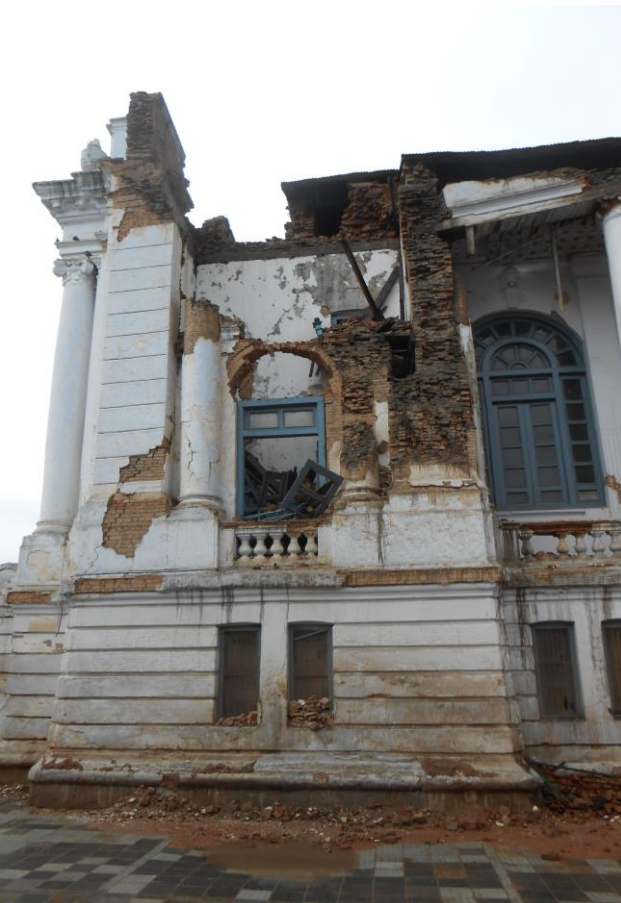
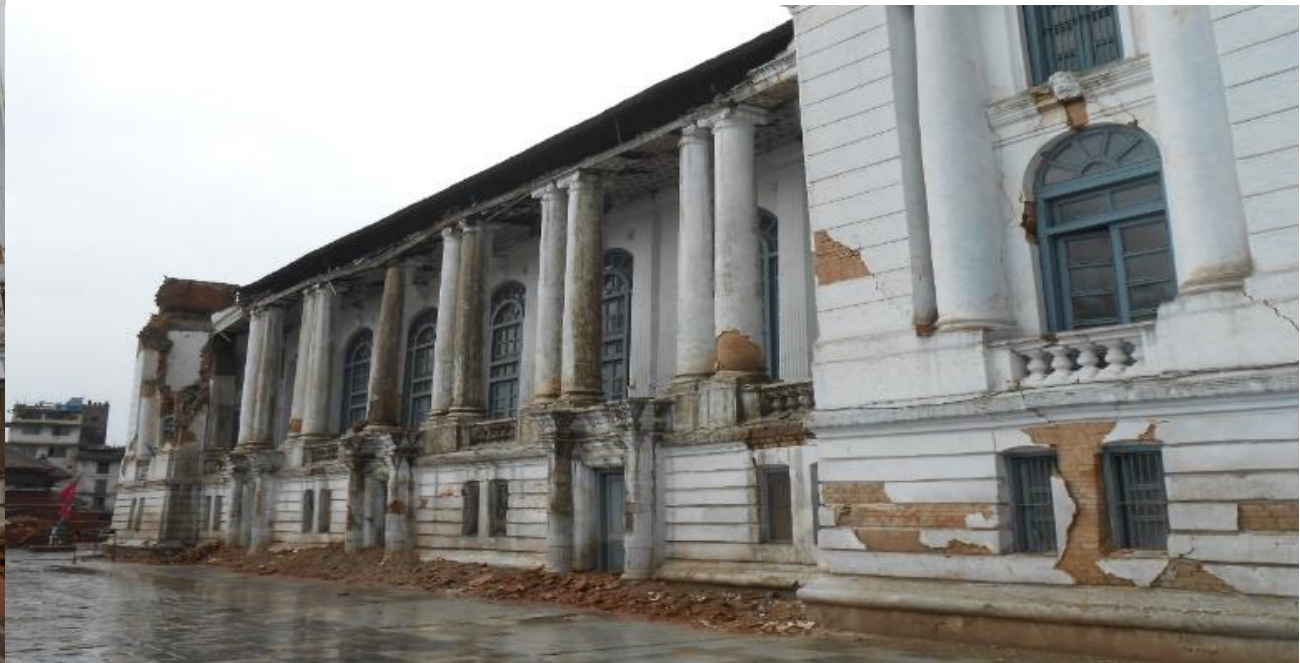
- Collapse of the corner structures
- Failure of the columns and parapet

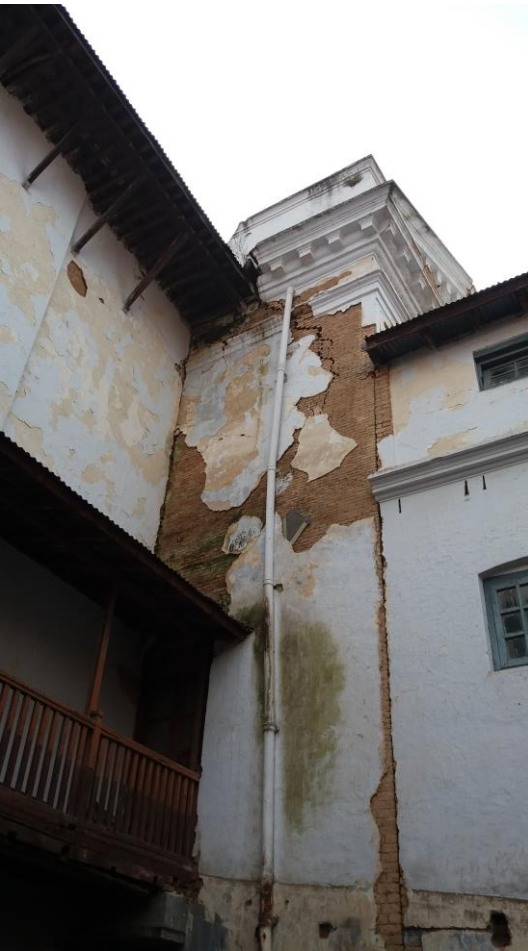
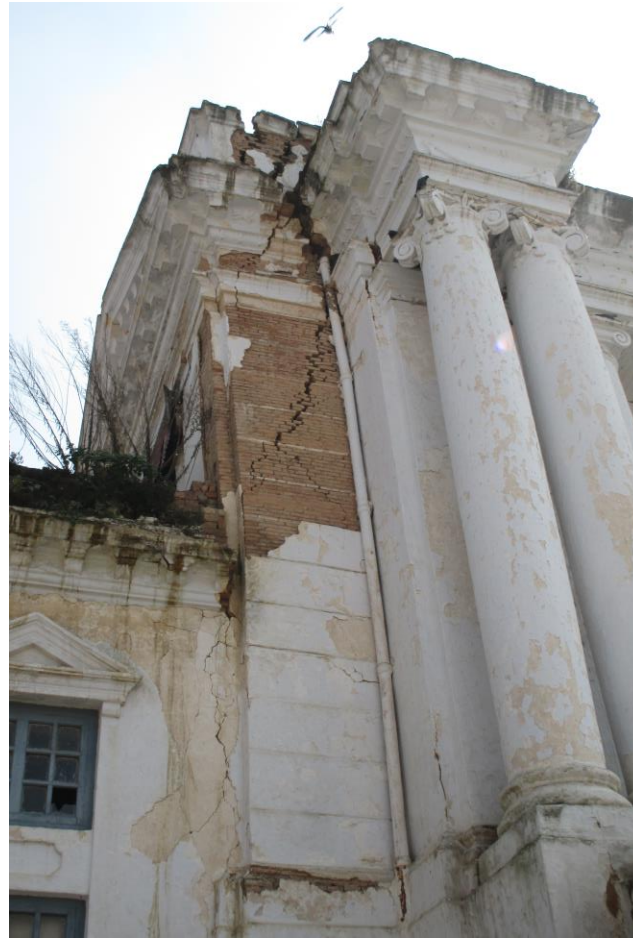
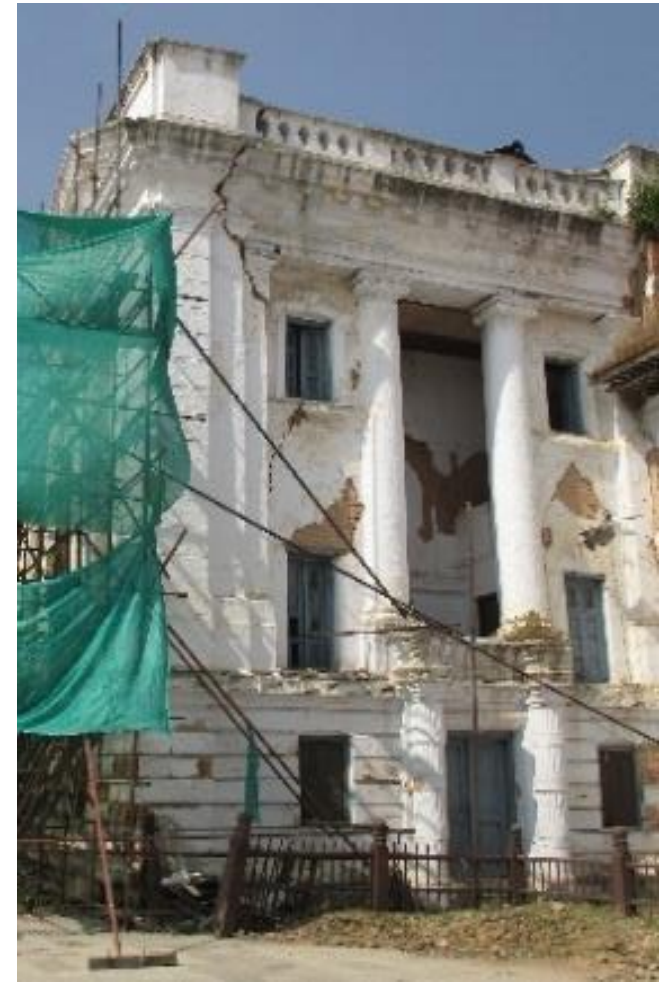
- Out-of-plane failures

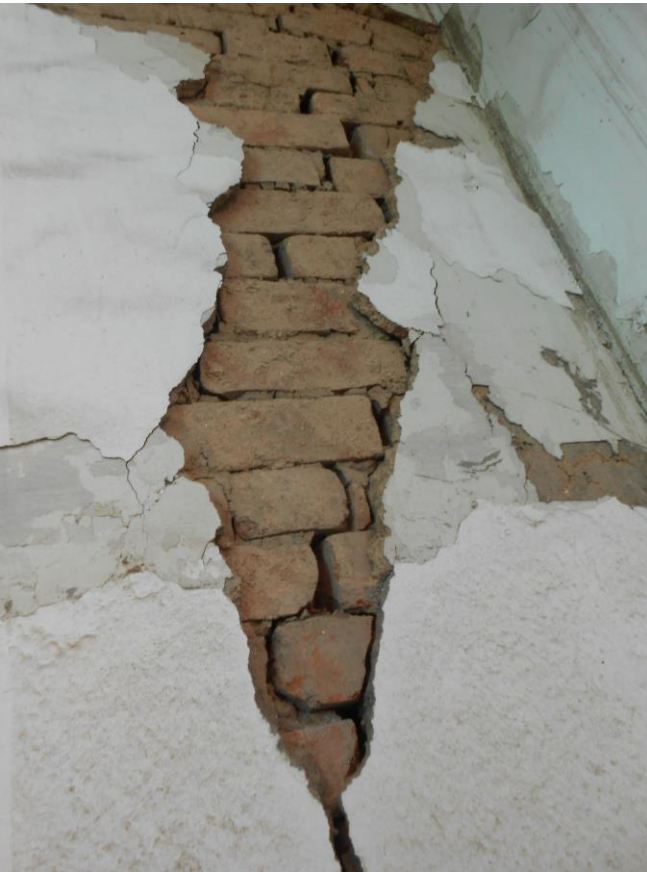
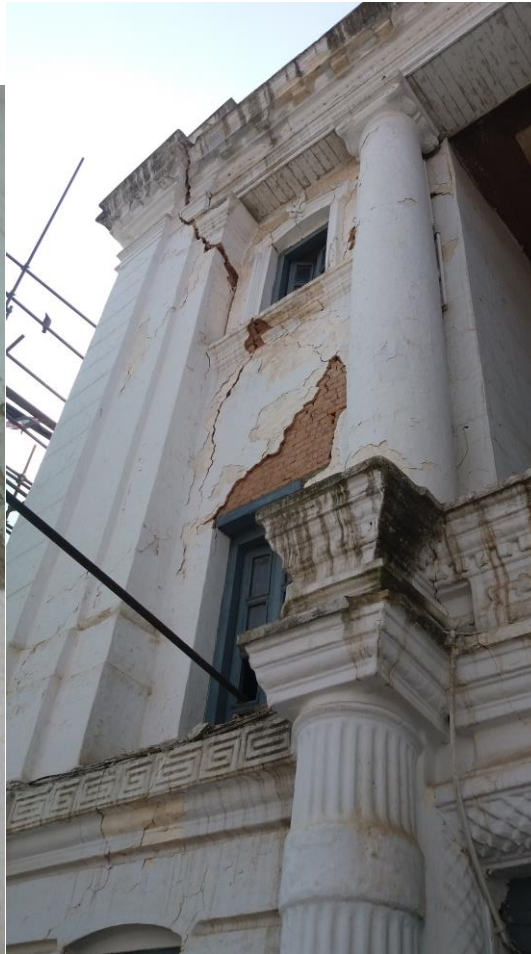
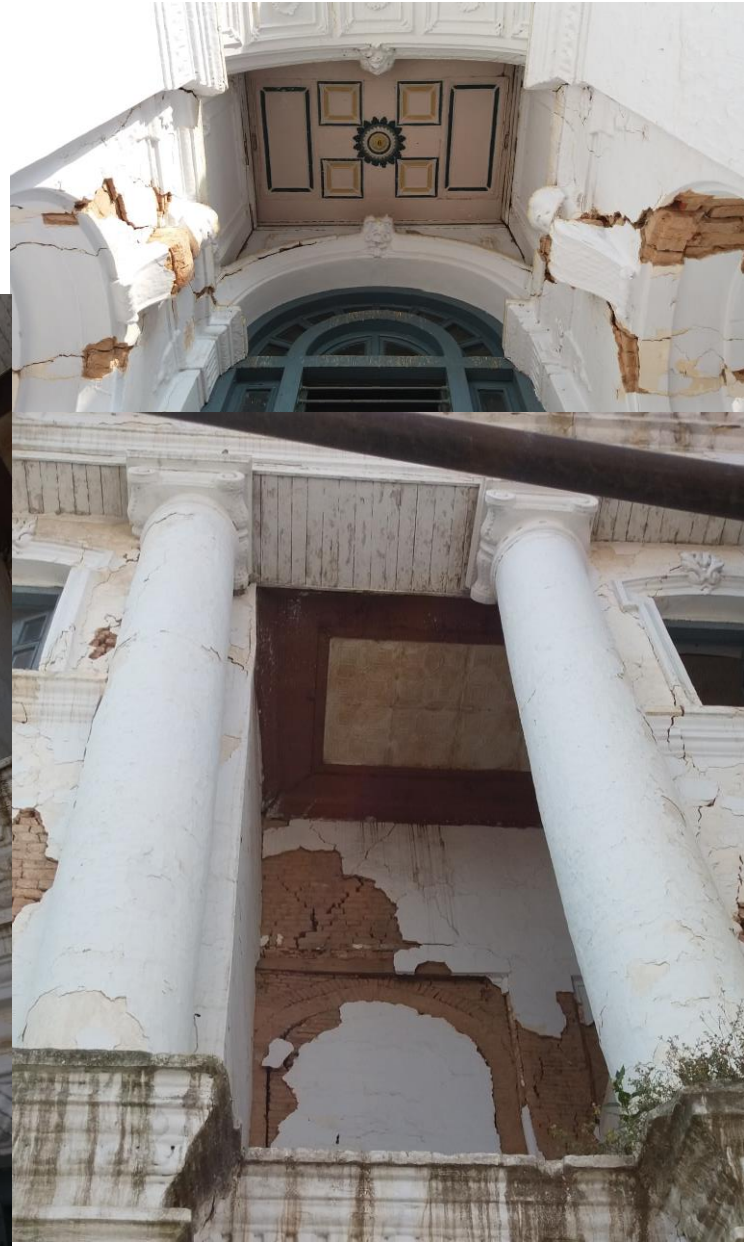
- Wall bulging

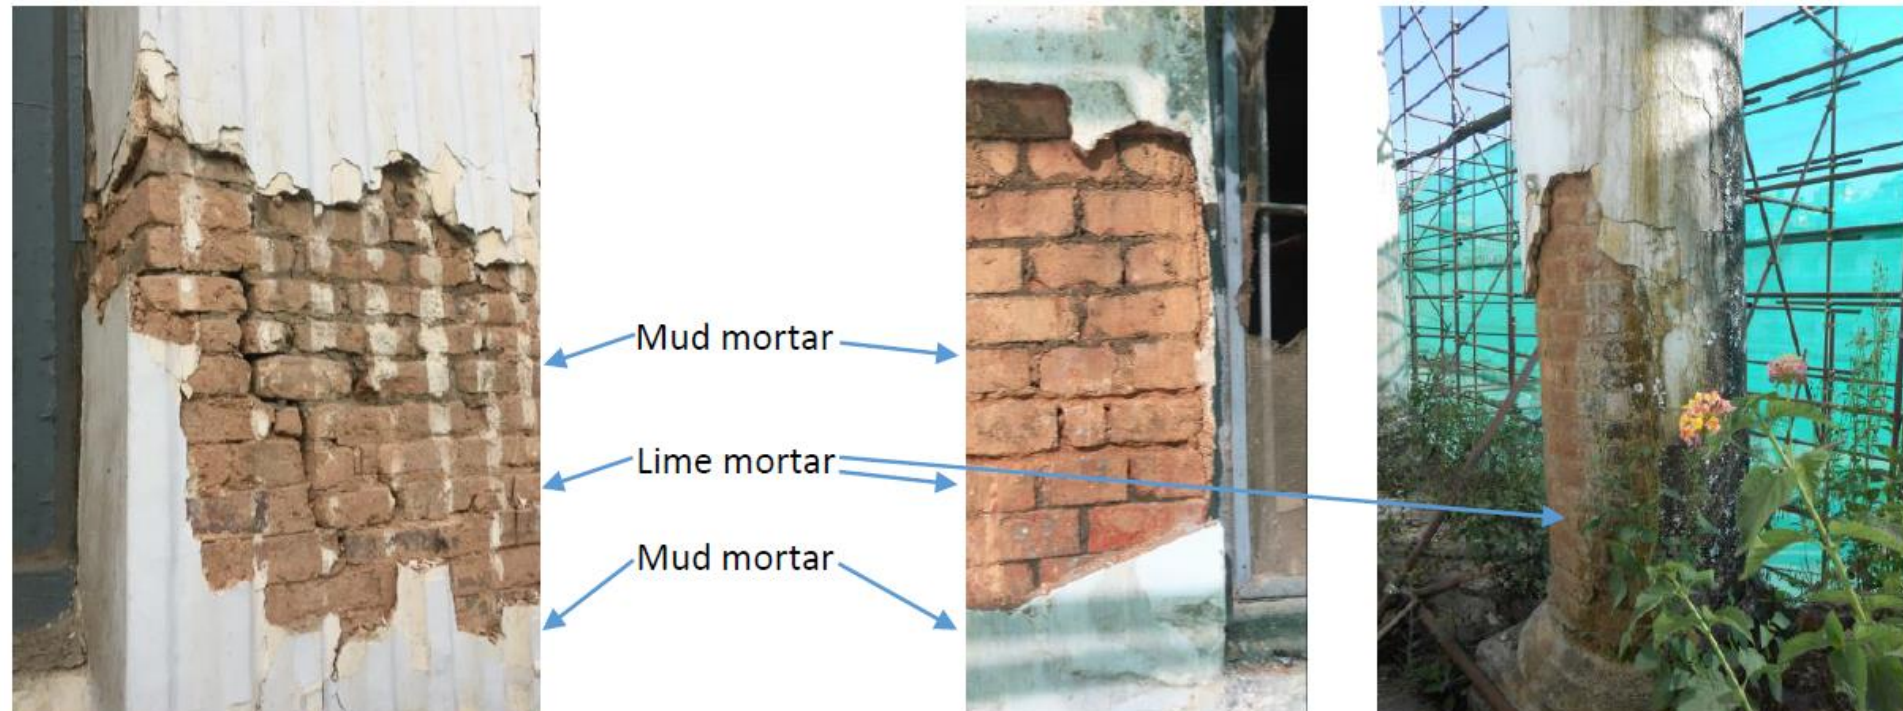
# Masonry work

Lime mortar in a few distinct locations. Parapet walls and columns contain solely lime mortar. Lime mortar within brick walls at horizontal intervals of approximately 1.8m.

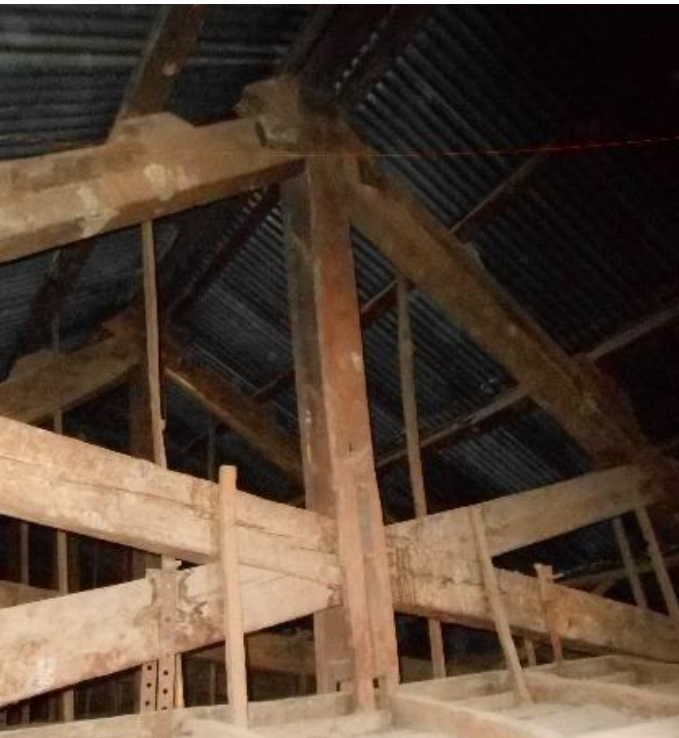
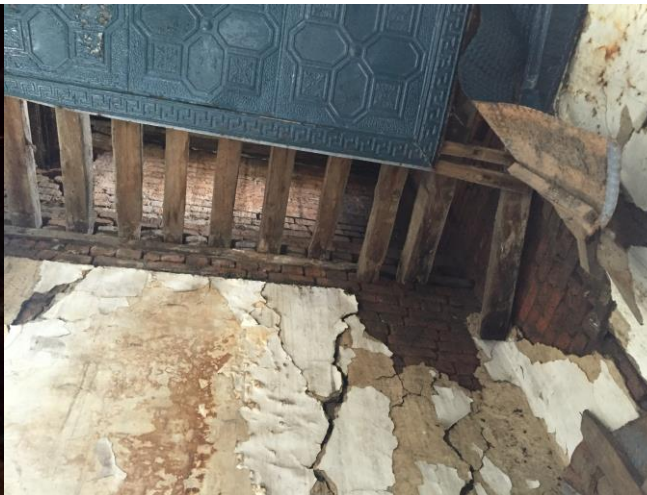
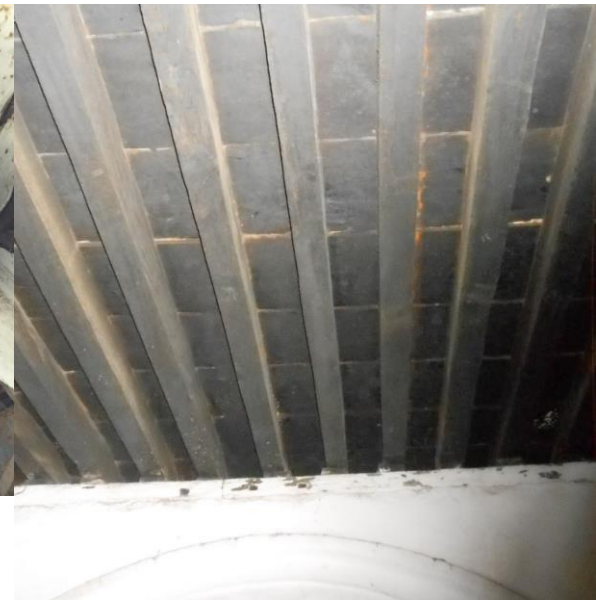
# Timber

- Roof Truss
- Ceilings and floors

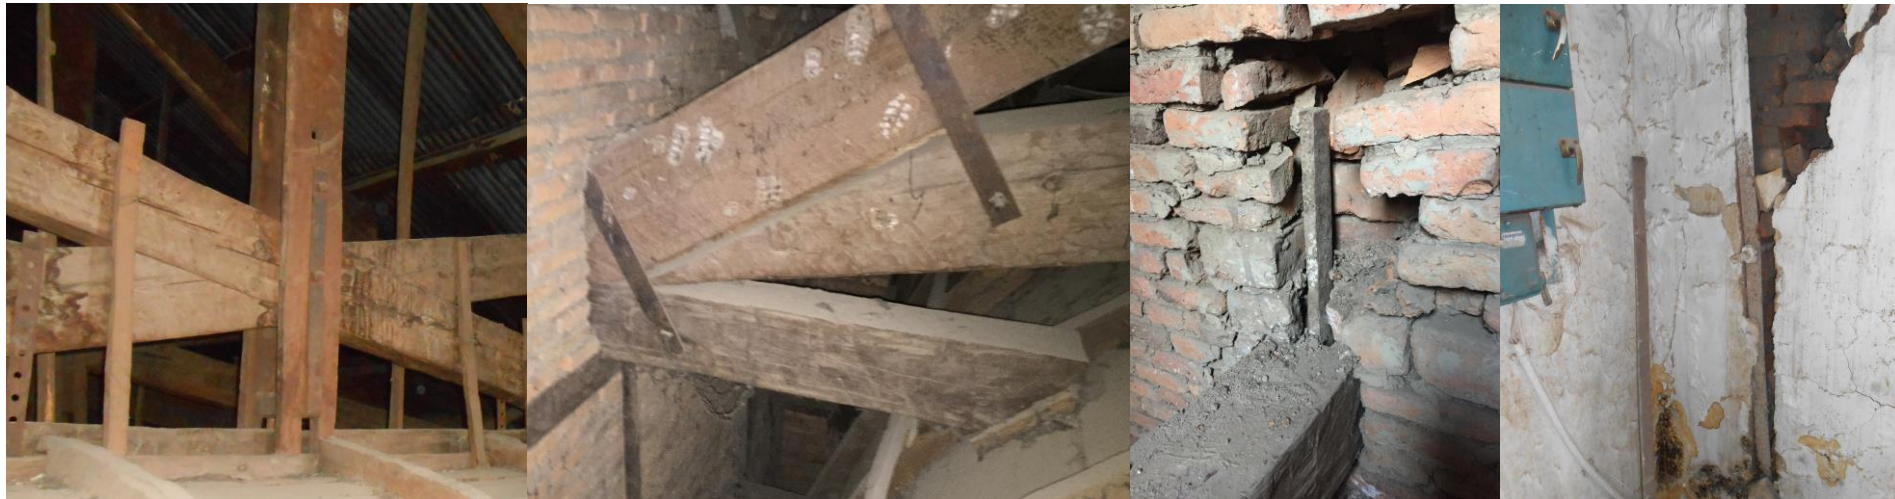
## Steel

- Reinforcing connection of timber truss
- Strap for ceiling
- Reinforcing strap to walls (potentially added after 1934 earthquake)

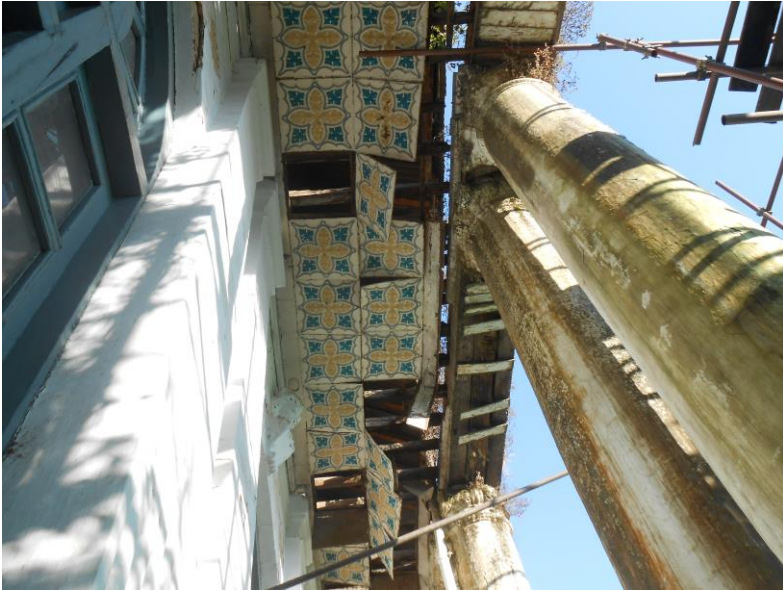
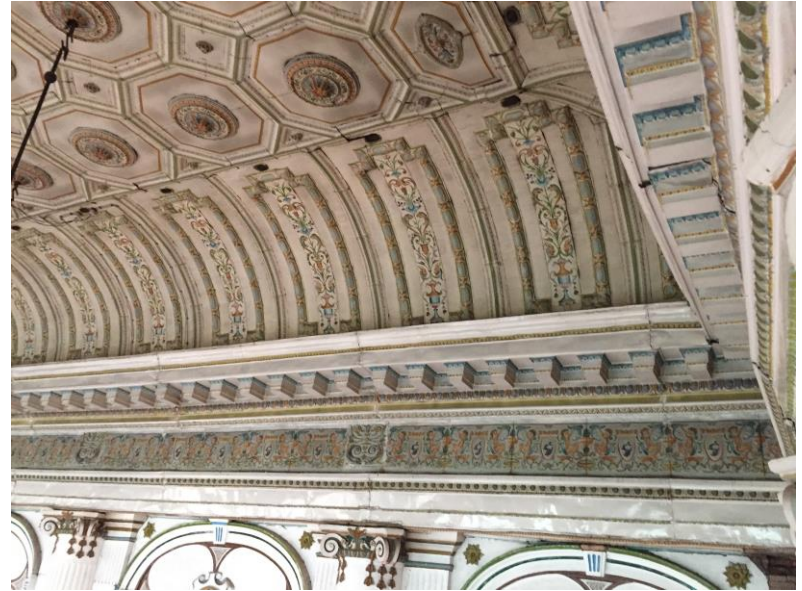
## Tin

- Ornamental metal sheet

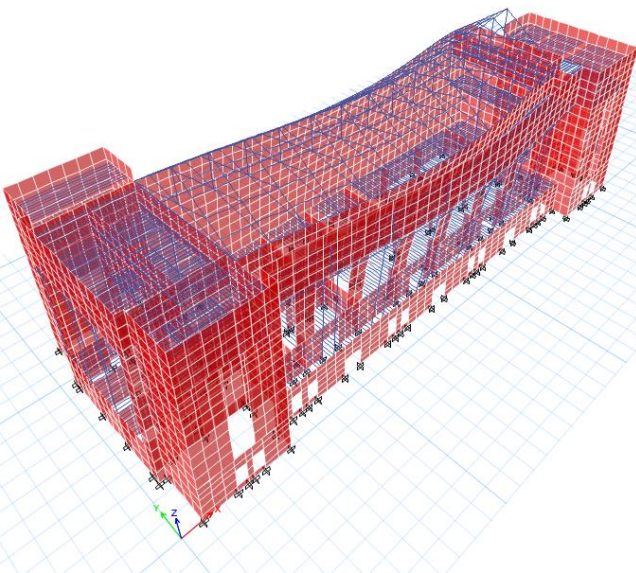
Mode Shape (Modal) - Mode 1 - Period 1.332

- 3 fundamental mode: 1.33, 0.71, 0.50 sec

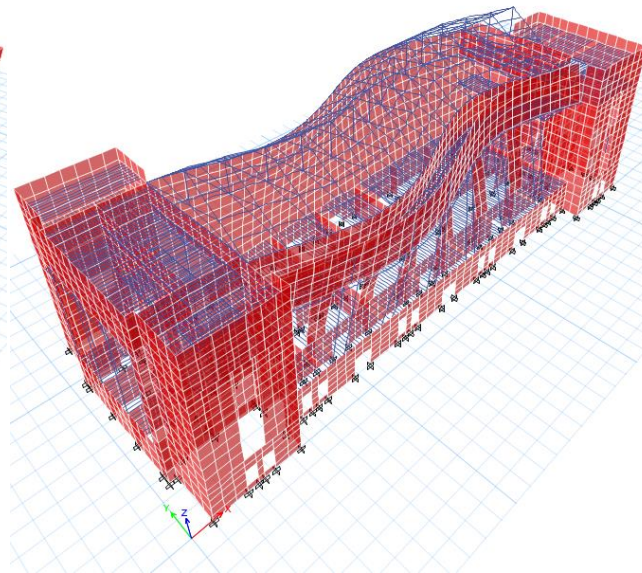
Mode Shape (Modal) - Mode 3 - Period 0.714

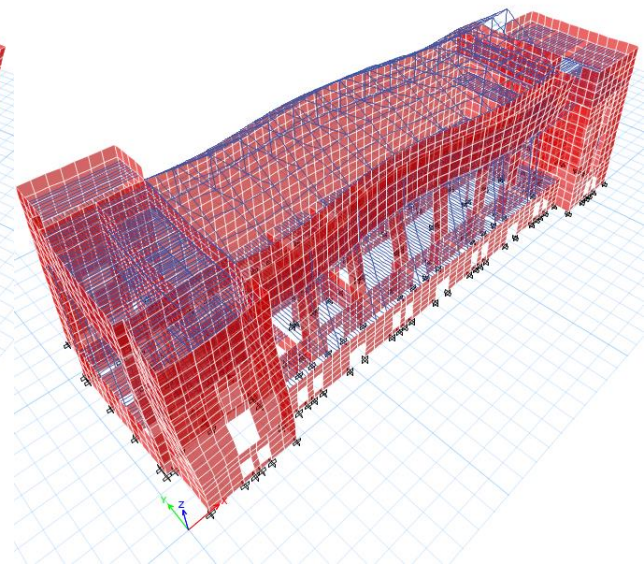
Mode Shape (Modal) - Mode 4 - Period 0.503

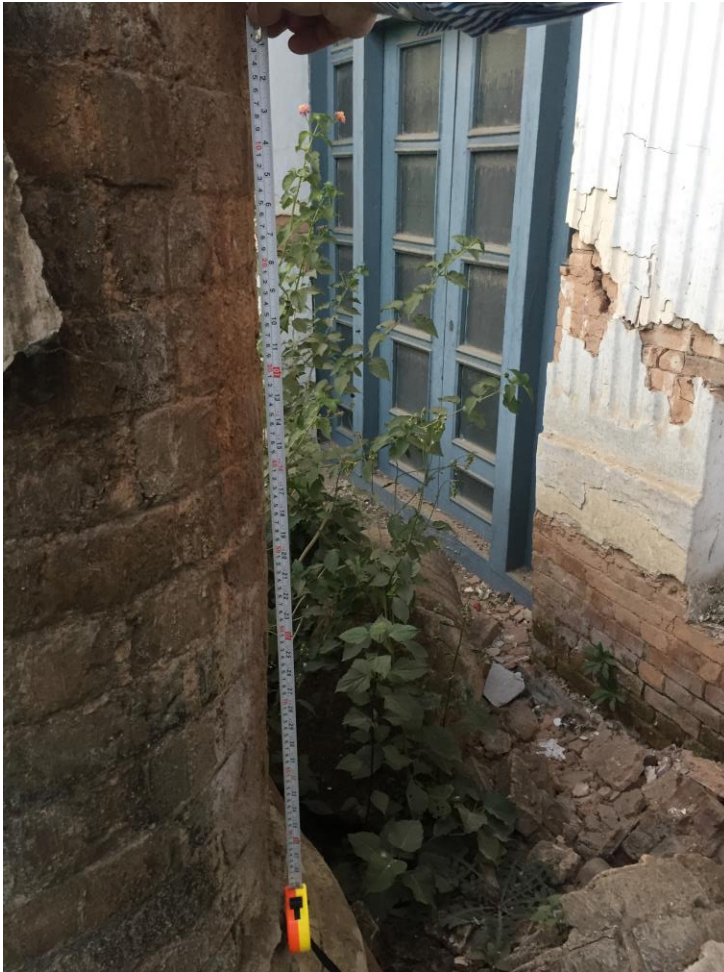
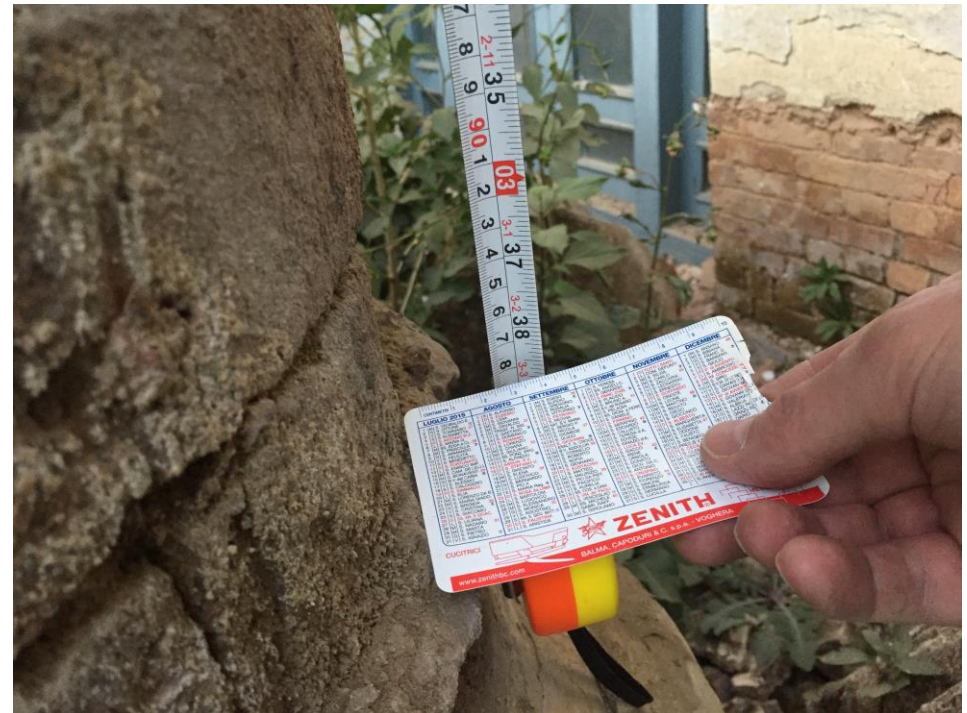
- Actual column displacement measured in site: 195 mm

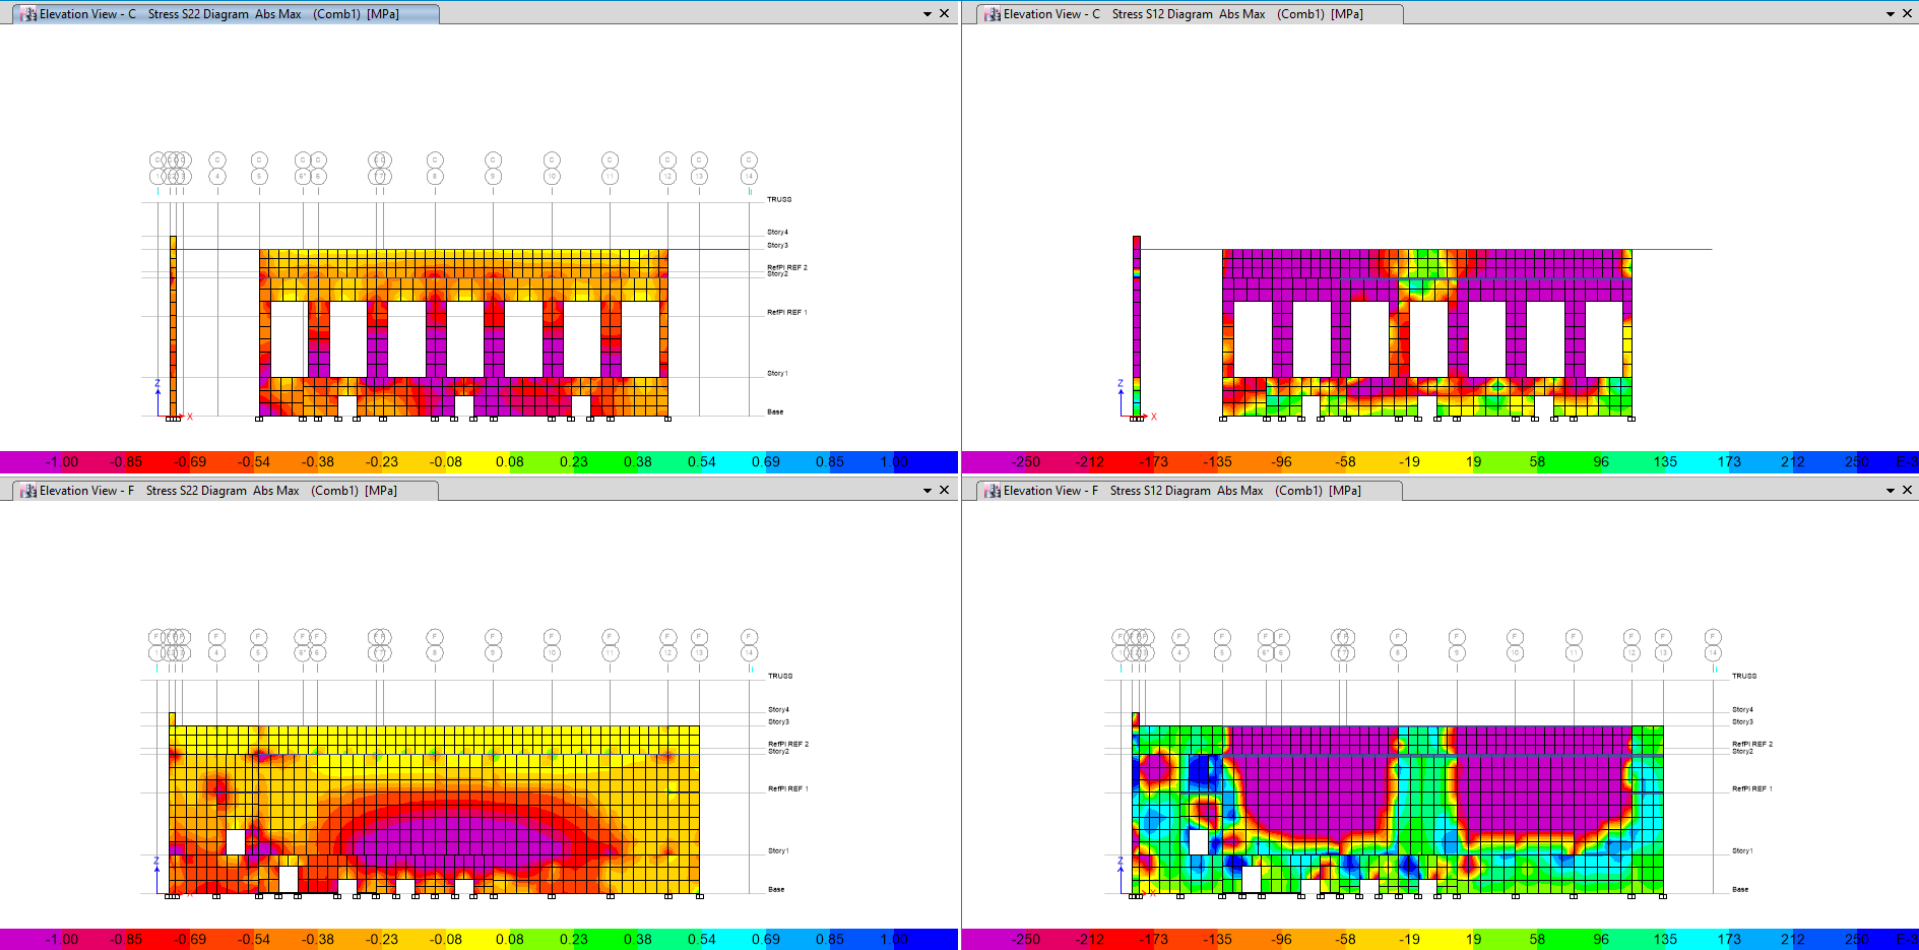
- Envelop of DL+LL+/-EL(A25)
- compression ( $\sim 3.0 > 0.87$ )
- shear stress ( $\sim 0.6 > 0.2$ ) exceeding in large areas

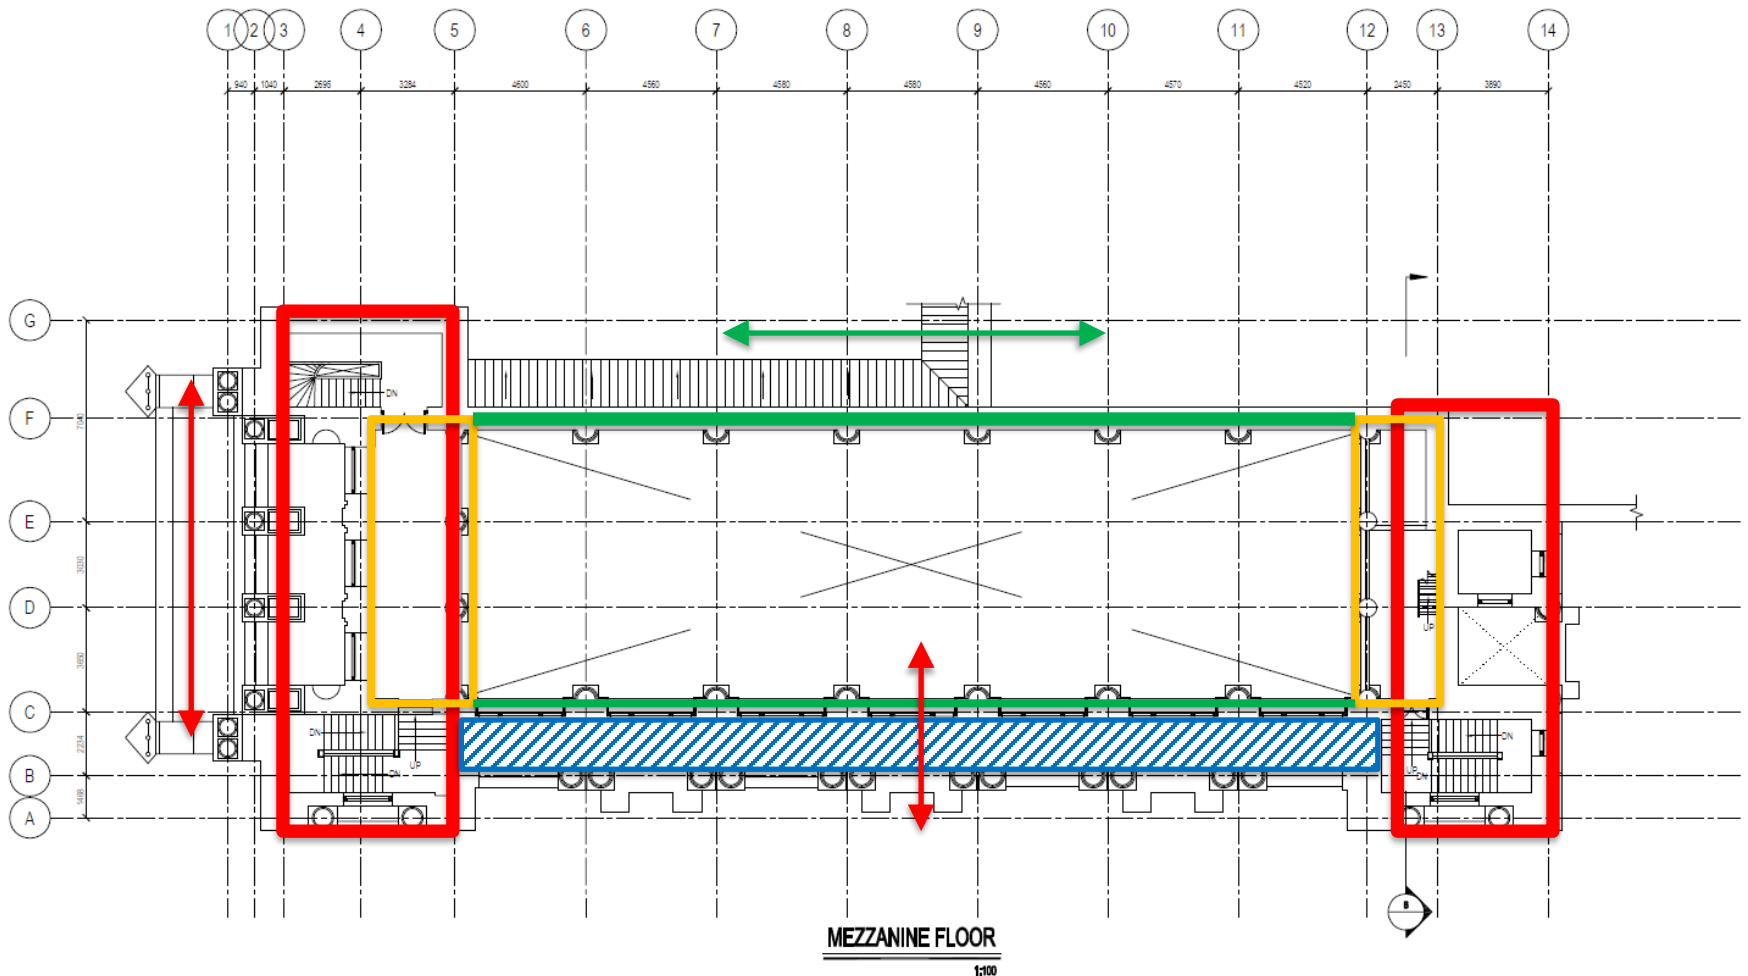
# Rigid boxes + Mezzanine + Long wall + Diaphragm ( Transitional zone ) ( cornice level )

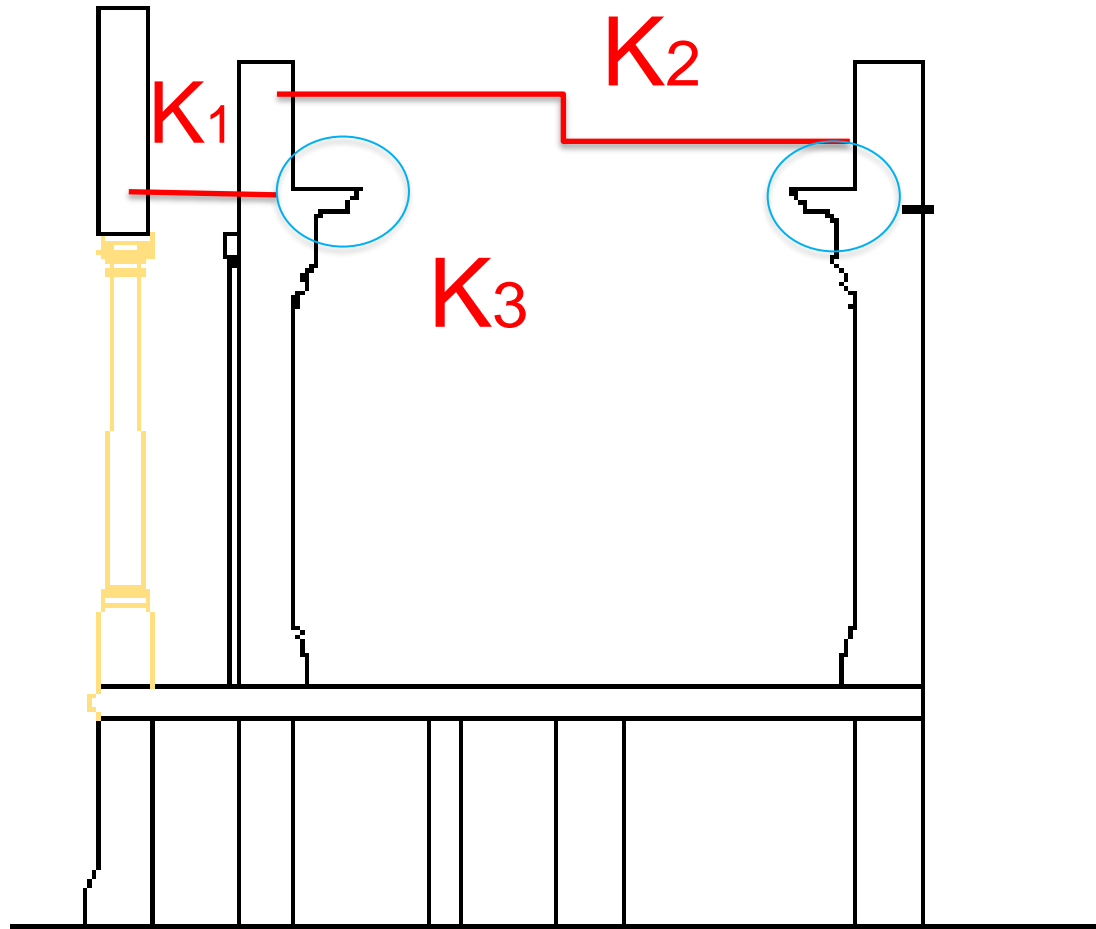
# Restoring proper combination of spring effects

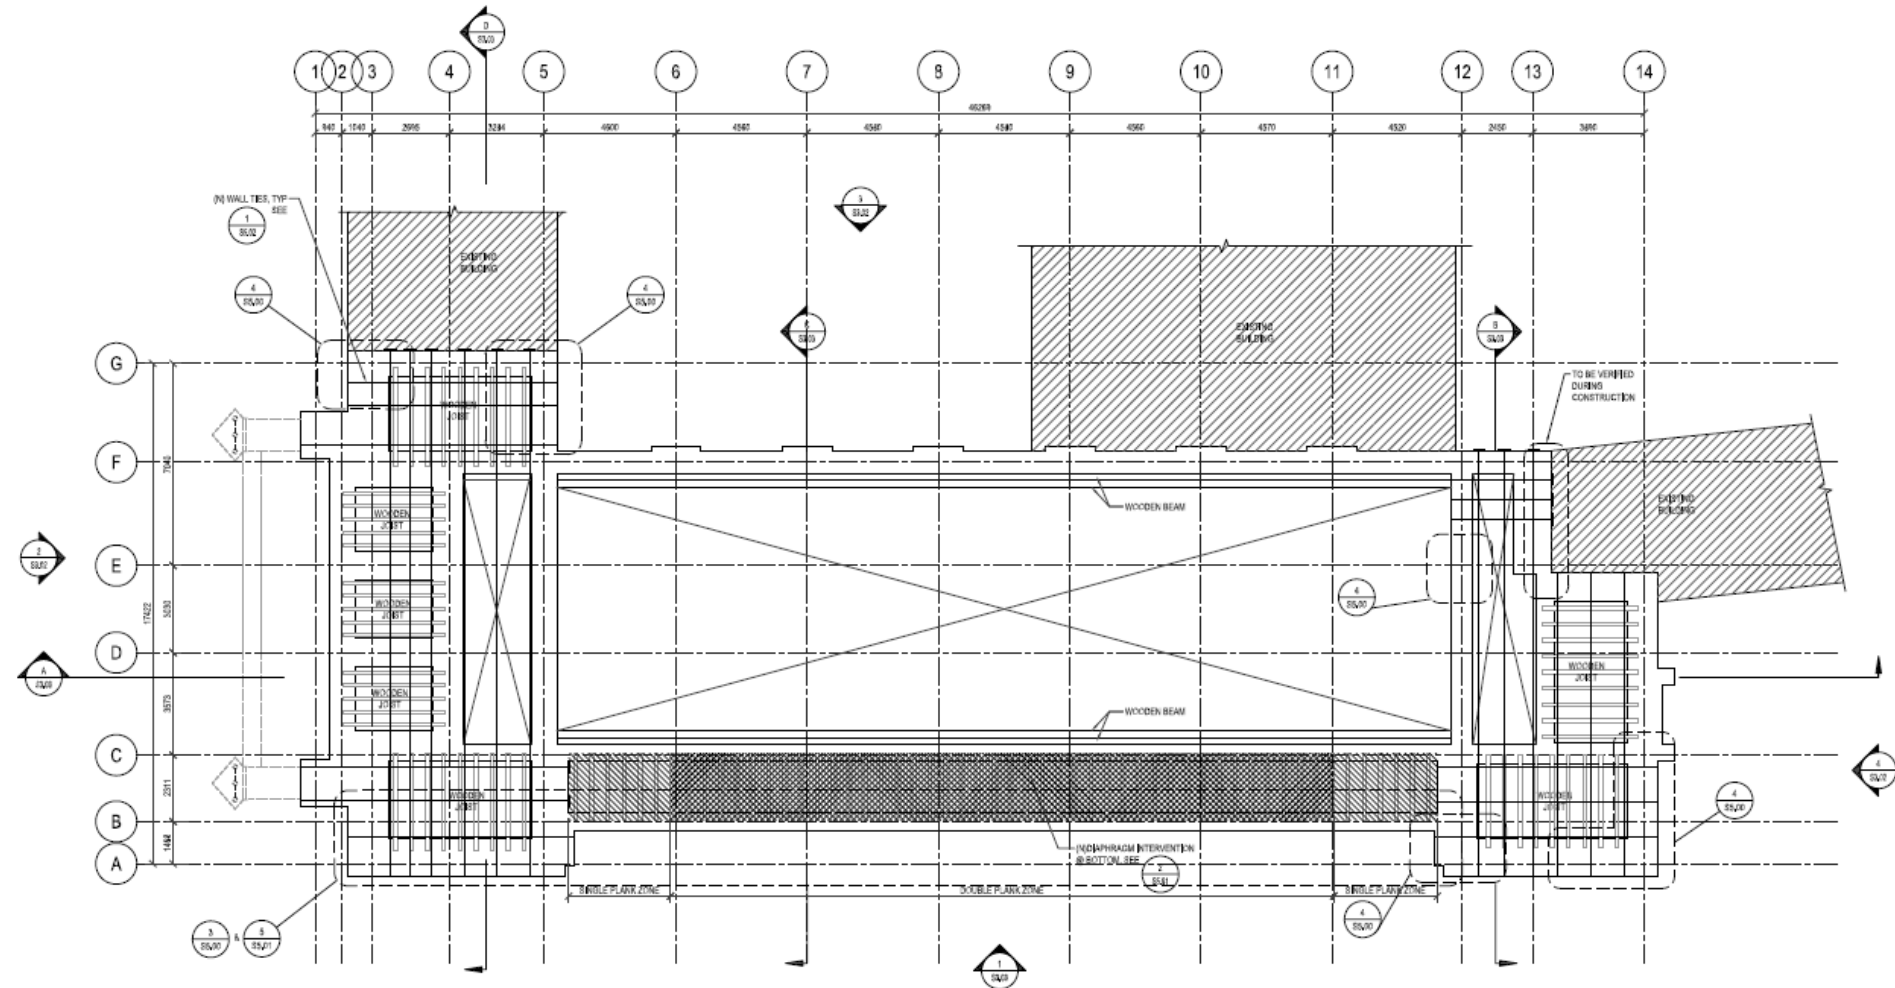
CEILING FLOOR PLAN

# Restoration/intervention of arcade diaphragm (K1)

- Detail of diaphragm interventions

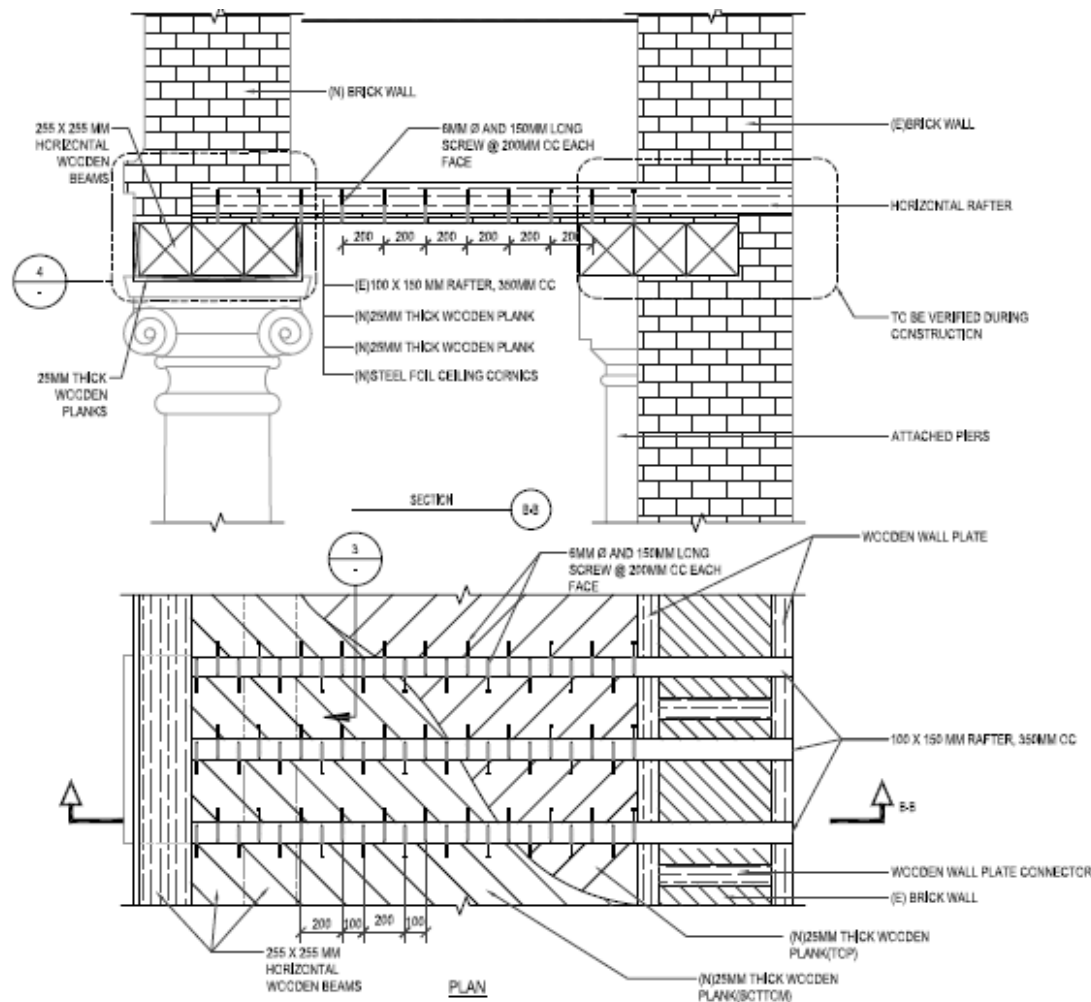
### DIAPHRAGM CONNECTION DETAILS

NOTE: PRE-DRILLING THE TIMBER IS HIGHLY RECOMMENDED TO PREVENT SPLITTING OF THE WOOD.

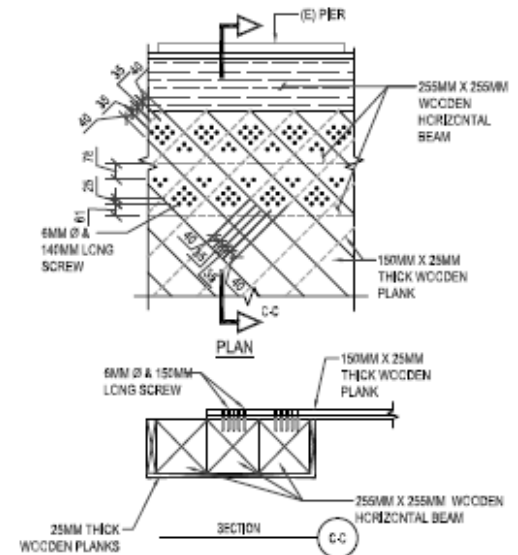
### PLANK TO BEAM CONNECTION DETAILS

NOTE: PRE-DRILLING THE TIMBER IS HIGHLY RECOMMENDED TO PREVENT SPLITTING OF THE WOOD.

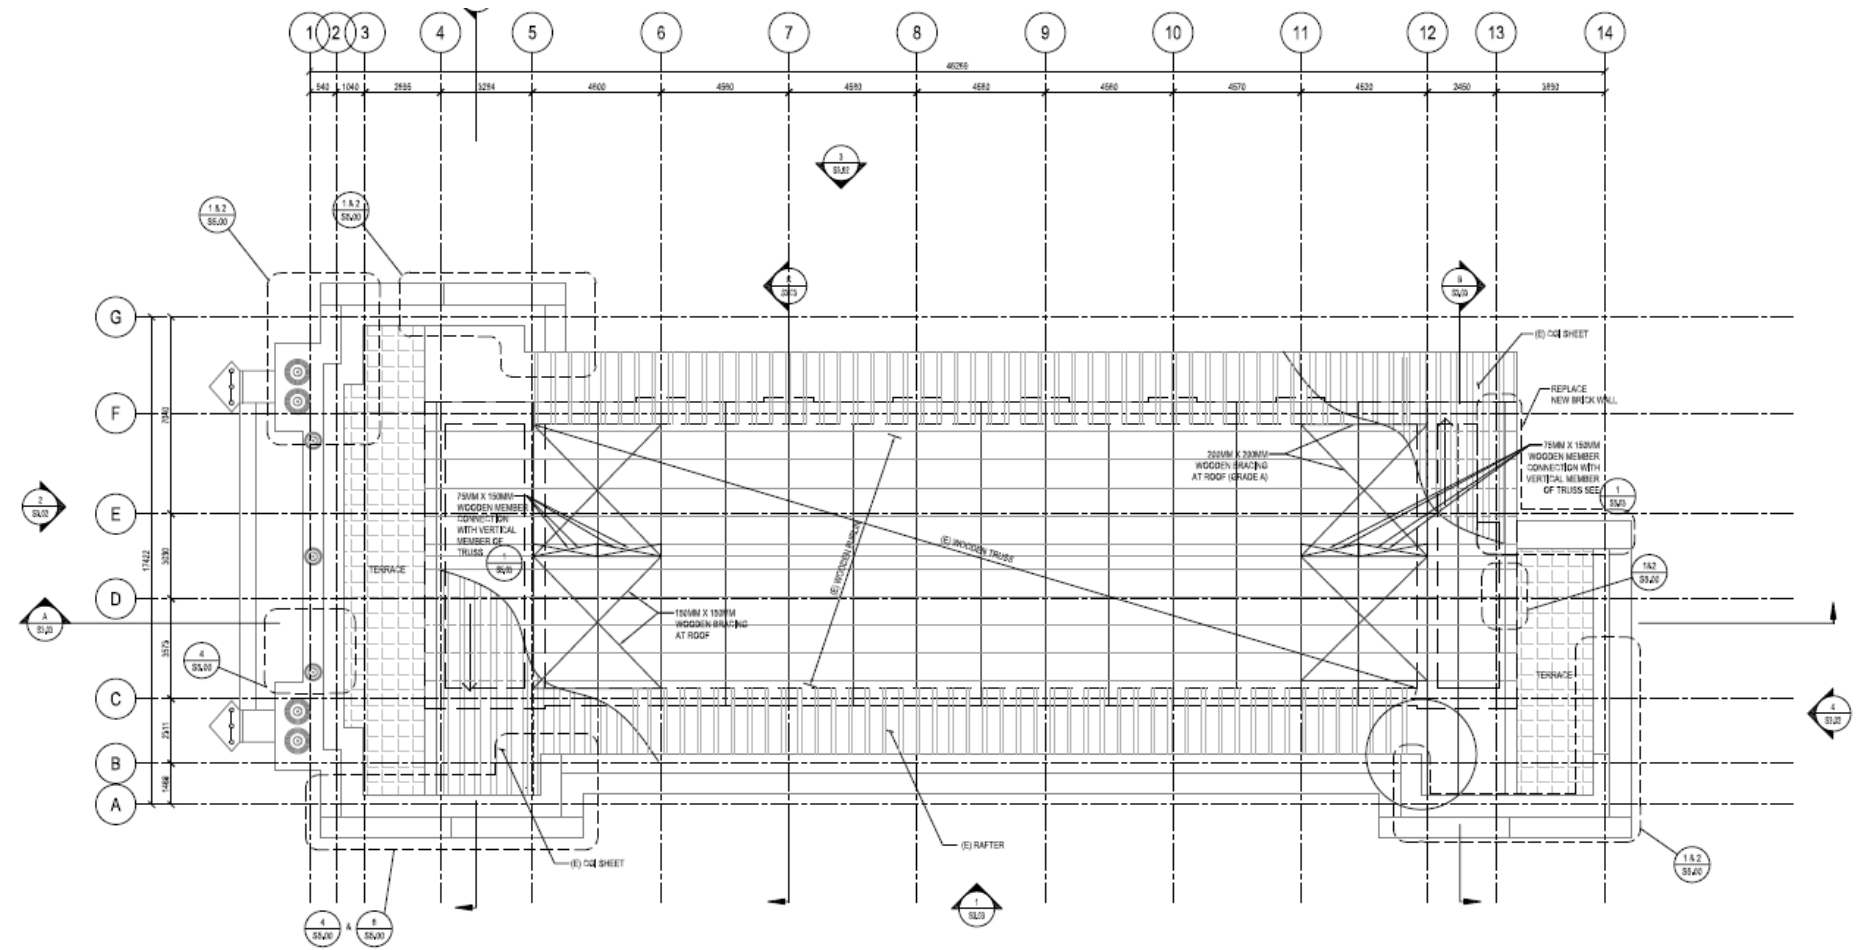
## Restoration/Improvement of Truss-Wall interaction (K2)

(enhancing timber roof beam function  
enhancing bracing effect of ceiling)

Architectural floor plan of a building with a grid system (Columns 1-14, Rows A-G). The plan shows a central hall area with a double layer of 151 mm wide and 19 mm thick wooden slats, and a central horizontal term x term wooden joist. The plan includes a staircase, a terrace above, and various structural elements like columns and beams. Dimensions are provided for various sections, and a note indicates that a retrofit is necessary for the structure.
