# *Post-Earthquake Repair and Strengthening of Historical Palace in Nepal*

Dr. Kit Miyamoto, SE  
Achyut Khanal, PE

### Restoration of the early 20th-century Gaddi Baithak

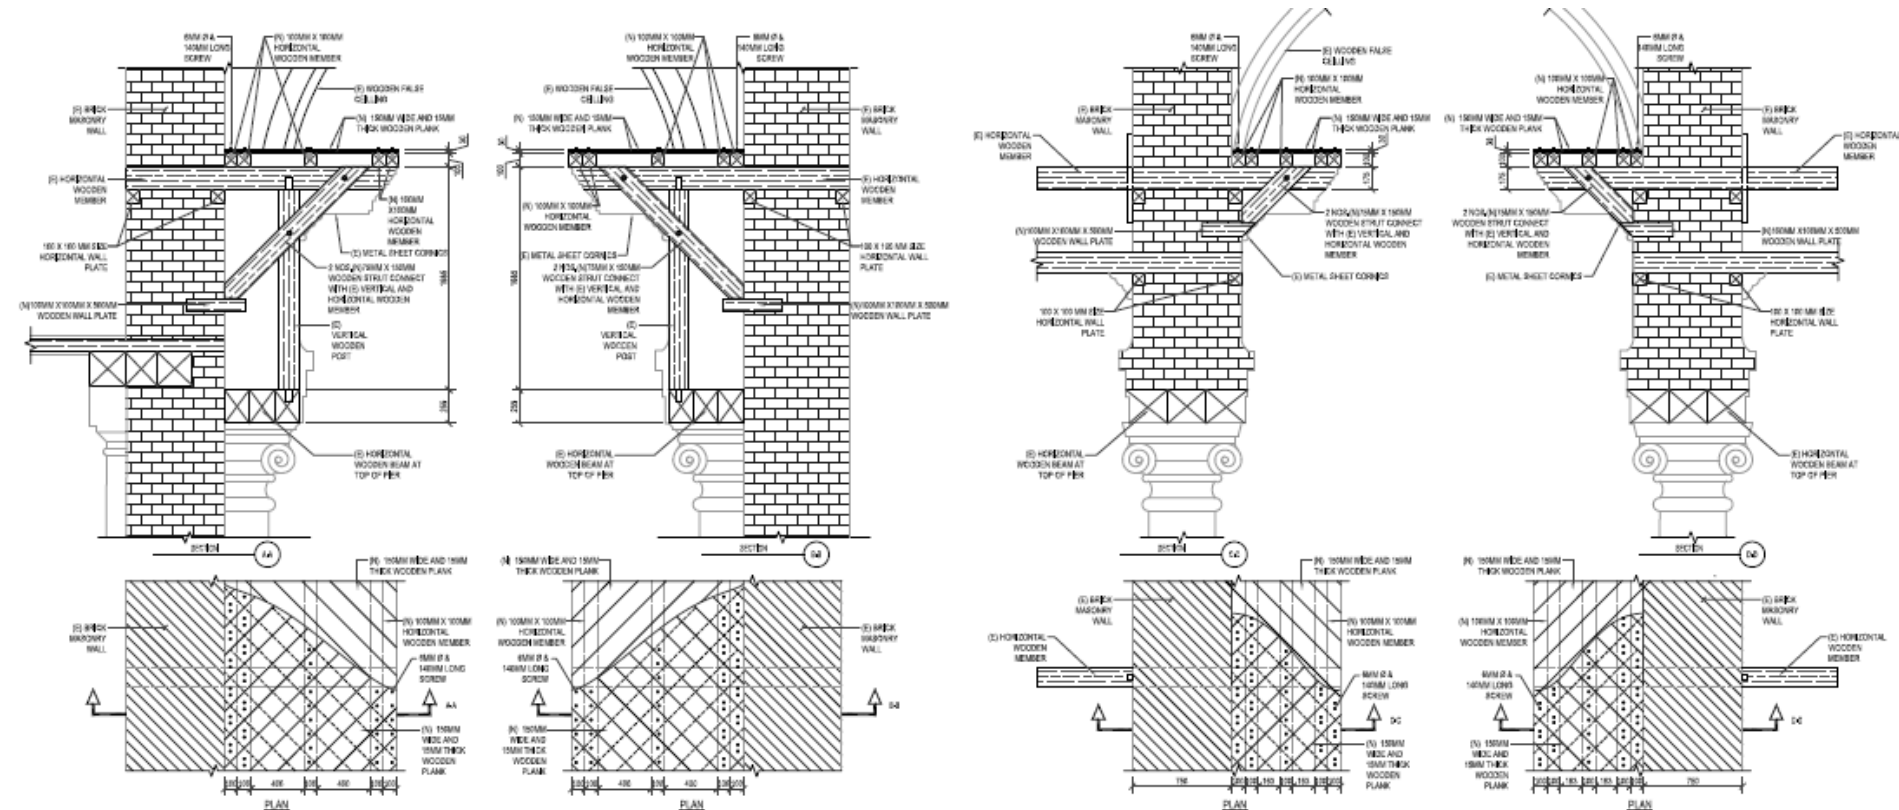
# Detail of Band diaphragm (k3)

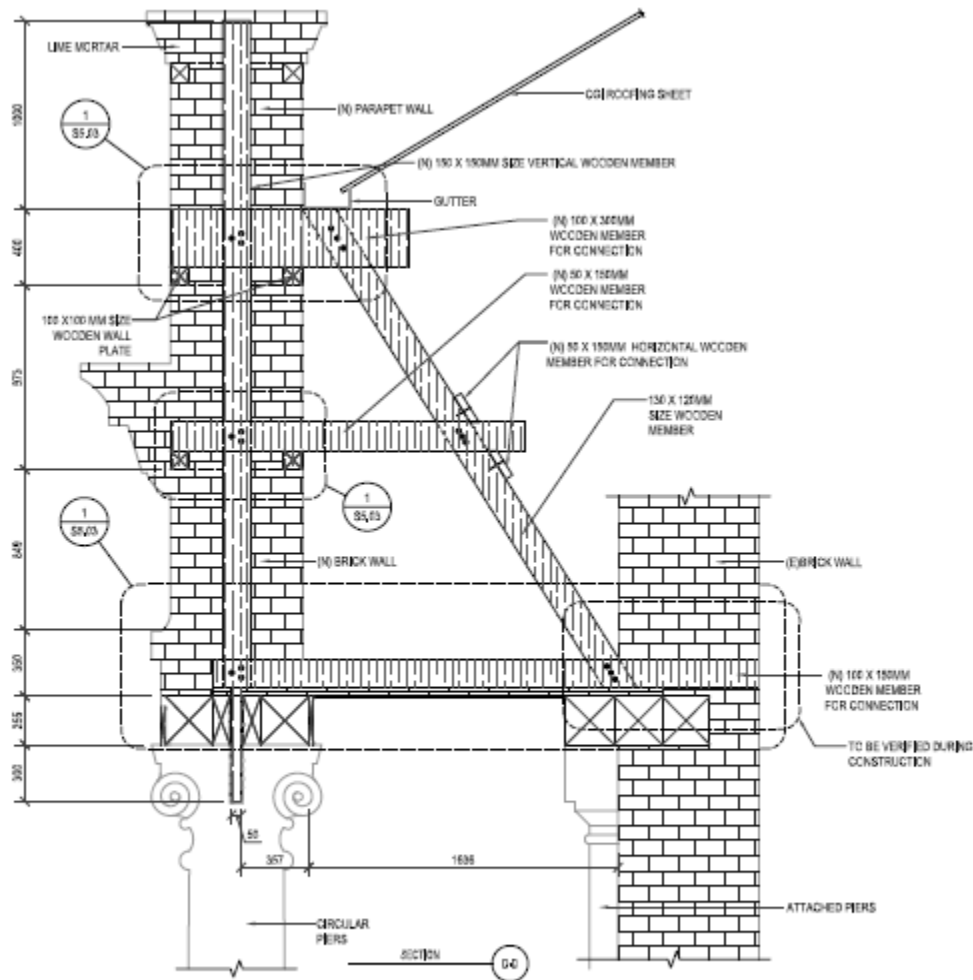
## Local interventions (prevention of parapet fall)

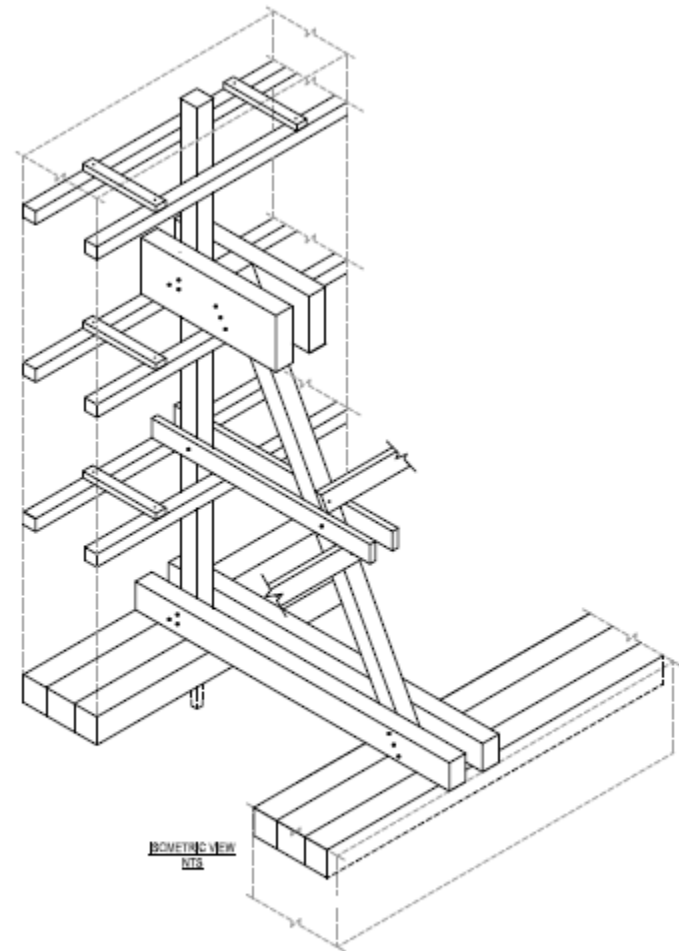
### CONNECTION DETAILS OF BRACING

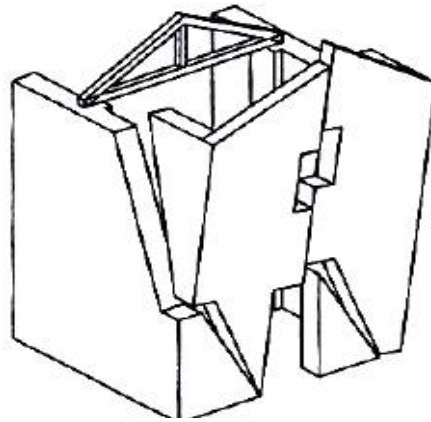
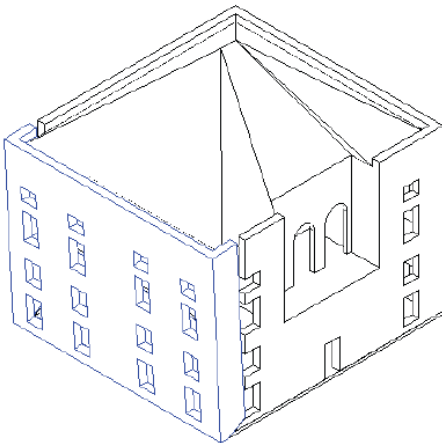
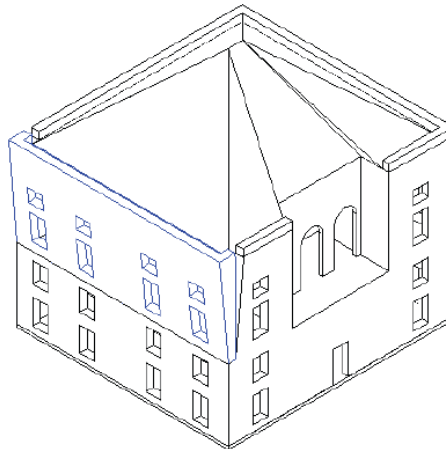
## Steel rod to keep box action

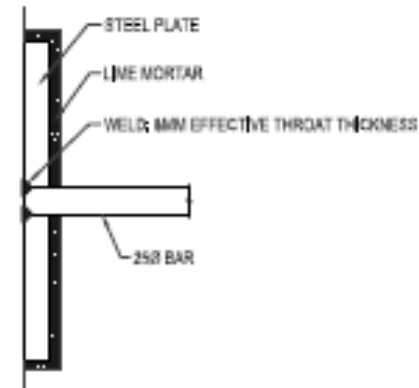
**DETAILS AT A**  
1:10

# Typ. Detail of steel rod interventions

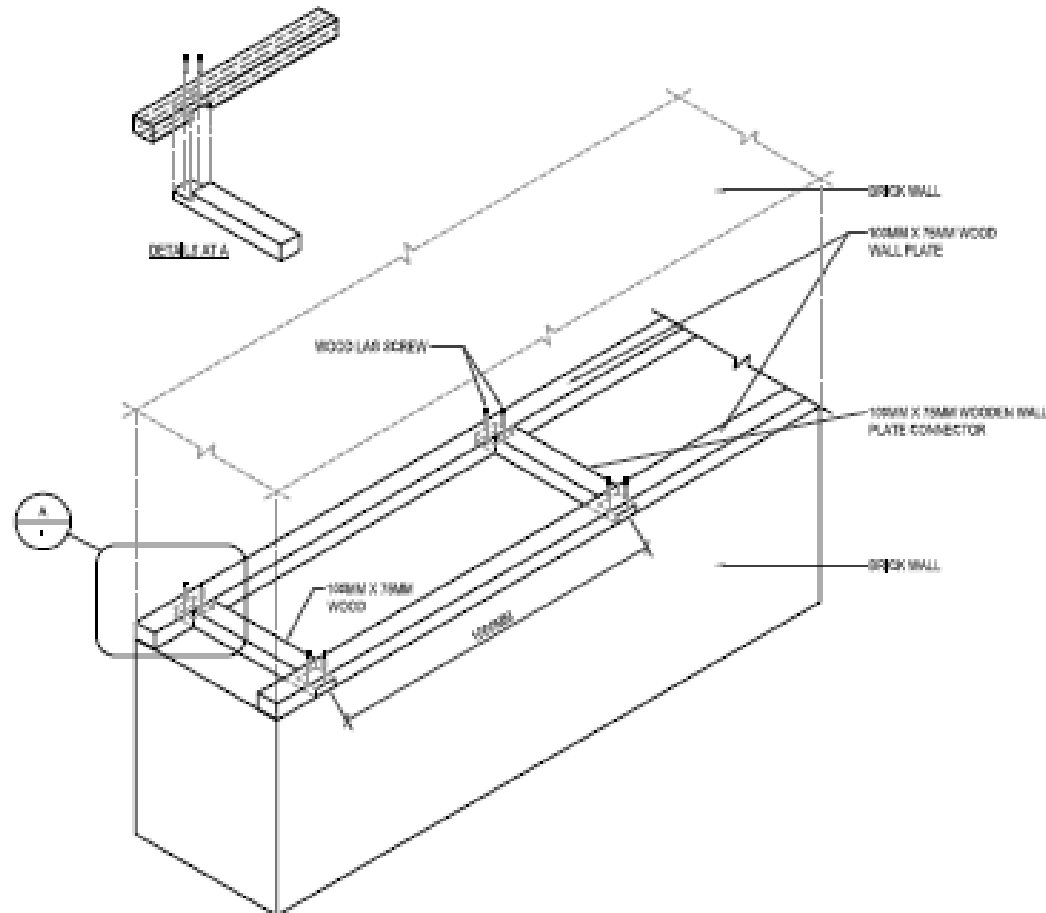
# Wood band in rebuilt brick wall

## Improve confinement of brick wall
